## MILE HIGH BLASTERS MOLD REMEDIATION REPORT

# 1510 S BROADWAY, DENVER

Basement mechanical room

SAMPLE-001

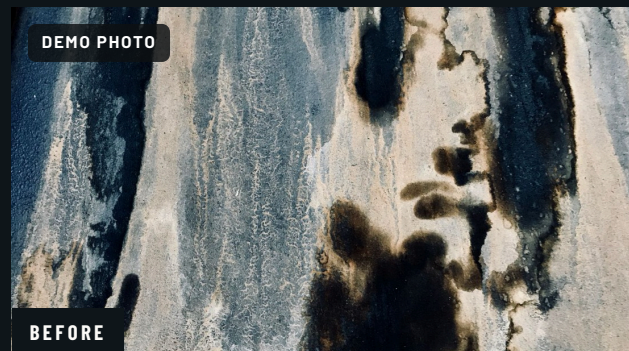
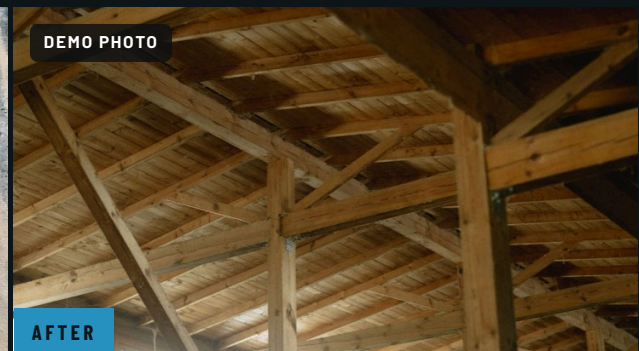
CONDITION 3

CONDITION 1

Growth present on arrival

Normal fungal ecology at completion

Likely moisture source: exterior grading or drainage directing water toward the foundation. Recommend correcting grade/downspouts at the marked wall.

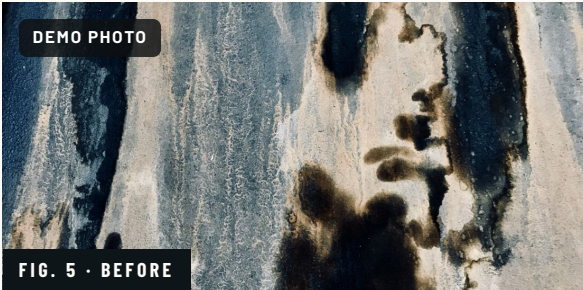
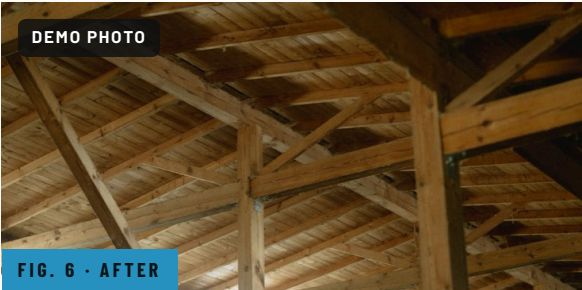
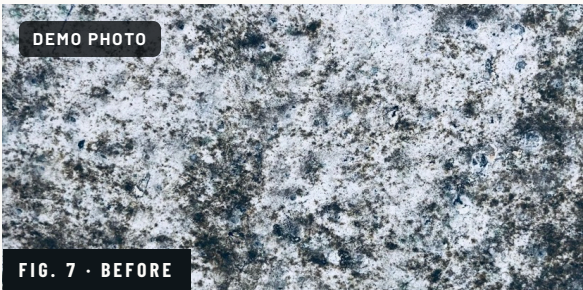
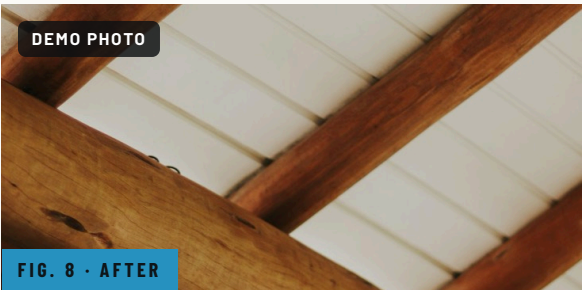
01  
BEFORE AND AFTER

Surface after dry ice blasting, same angle as the pre-work photo. Growth removed from the substrate without added water or chemicals.

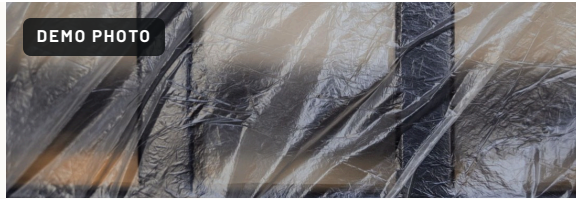
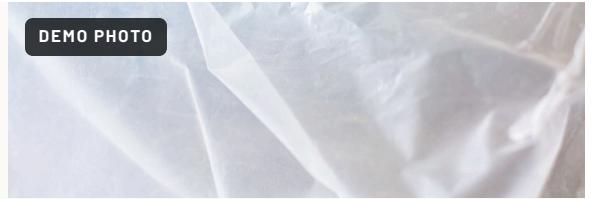
Fig. 3 · Containment and engineering controls

Fig. 4 · Containment and engineering controls

| SCOPE | Joist bays and rim joist at the NE corner, ~180 sq ft. |
|---|---|
| CONTAINMENT | Containment established with 6-mil poly sheeting and zip-wall at the affected area. Negative air maintained for the duration of the work. |

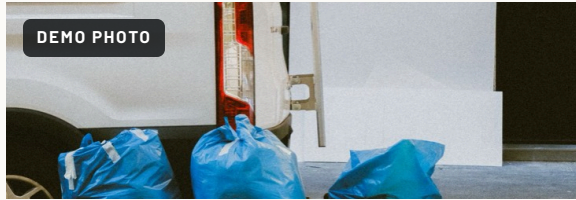
Fig. 9 · Waste removal and HEPA vacuuming

Dry ice blasting (solid CO<sub>2</sub> media), followed by HEPA vacuuming and waste removal. No water and no chemical biocides were introduced.

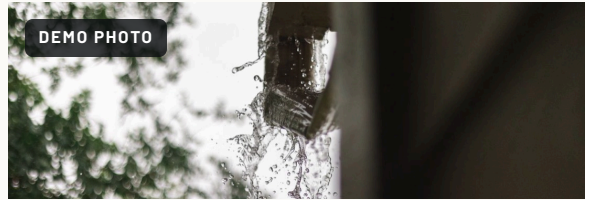
Fig. 10 · Moisture source observation

Likely moisture source: exterior grading or drainage directing water toward the foundation. Recommend correcting grade/downspouts at the marked wall.

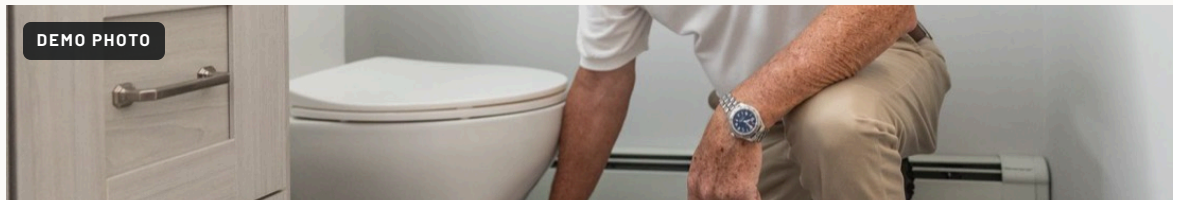
Fig. 11 · Verification

Visually clear of growth · No musty odor remaining

Same meter, same locations as the pre-remediation readings. Substrate returned to the reference range for this material.
