## MILE HIGH BLASTERS EQUIPMENT CLEANING REPORT

# 820 UMATILLA ST, DENVER

Plant 2 · packaging hall

SAMPLE-002

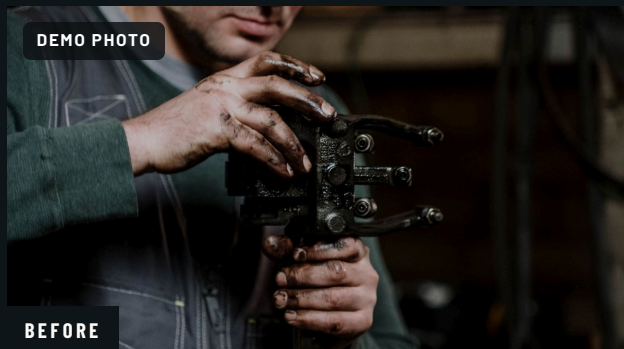
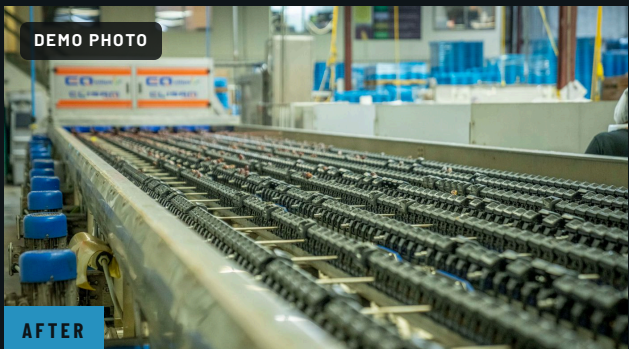
Baked-on grease, carbon and product residue removed from Line 3 conveyor frame, drive housing and guarding by dry ice blasting, in place, without water or chemicals.

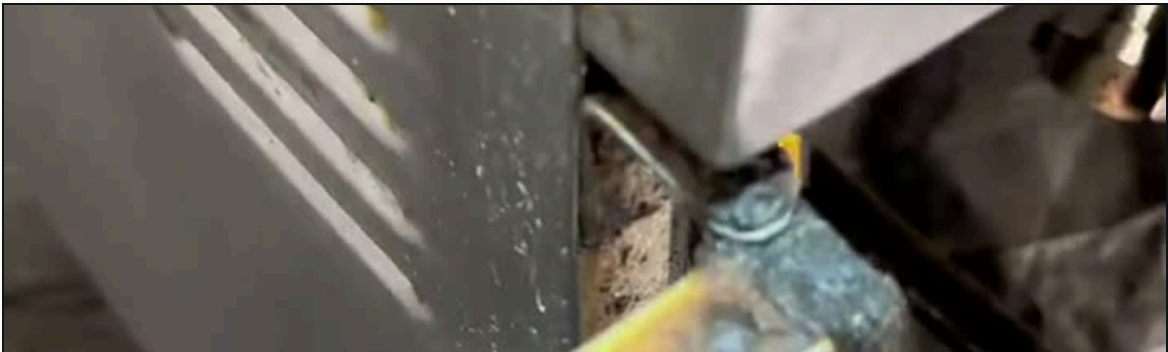
**Demo footage · from the walk-through** · Baked-on residue lifting off the frame under the nozzle. Silent, unedited, run at real speed.

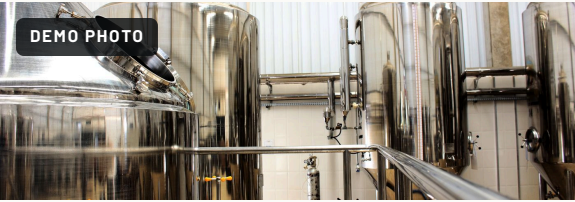
Fig. 3 - Masking and protection of adjacent surfaces

| MASKING | Adjacent surfaces and sensitive components masked before work began. |

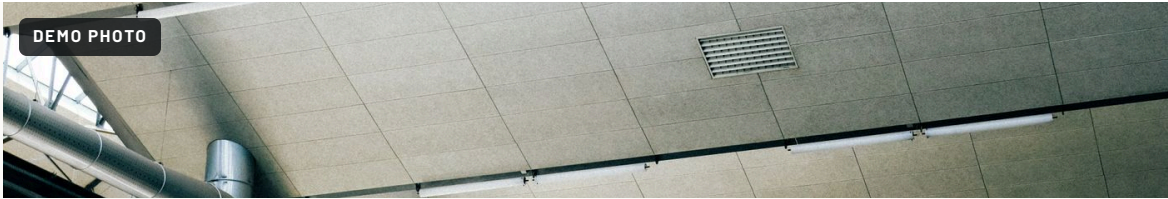
Fig. 10 · Back in service

**Checked back in service - No media or residue left behind**

Masking removed and the line handed back to the plant. Cleaned in place during the scheduled changeover – no additional downtime was taken.
